REFERENCE: Pearson 10M # 61

SUBJECT: Pearson 10M Chainplate/Gusset
Field Fix Procedure

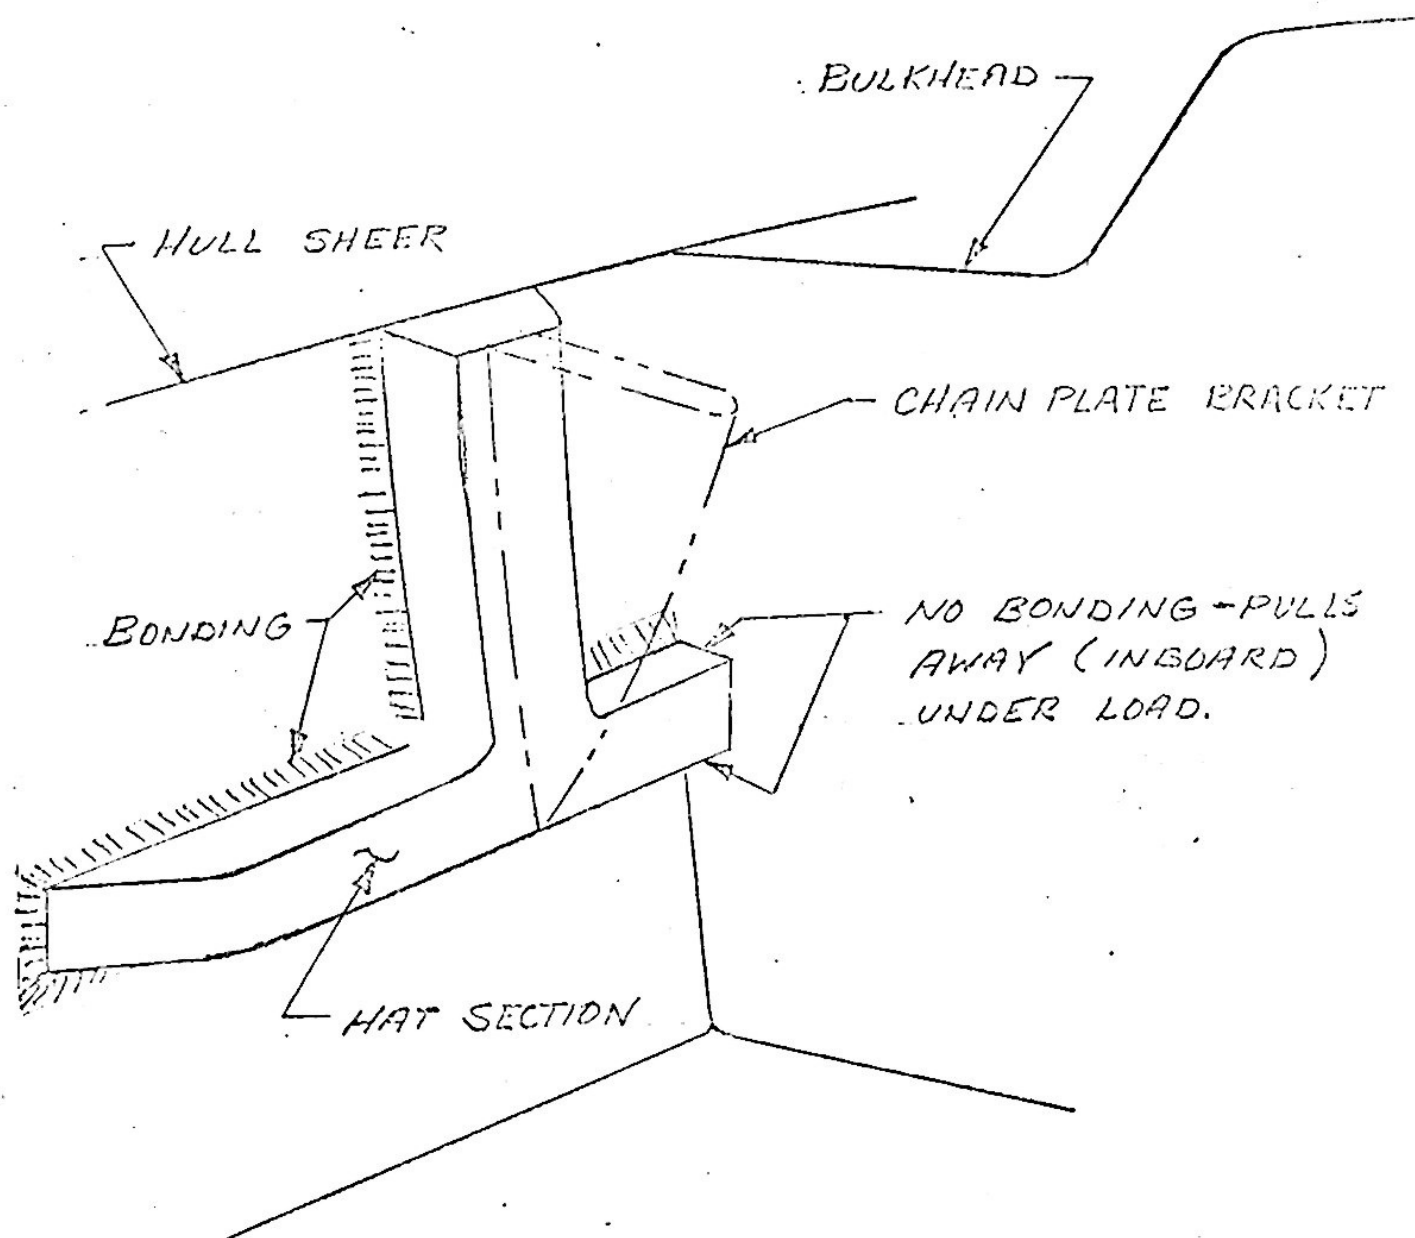
Referring to Figure 1, this indicates the general construction in way of the chainplate. You will note the large hat sections to which the triangular chainplate bracket is attached. The hat sections are bonded to the hull on their vertical and horizontal edges. Bonding at the forward end of the horizontal hat section may be insufficient and might break loose from the main bulkhead. When putting the shrouds under load, relative movement between the hat section and the bulkhead may be observed.
