October, 1974

Pearson-10M #61

SUBJECT: Lifeline Locknuts

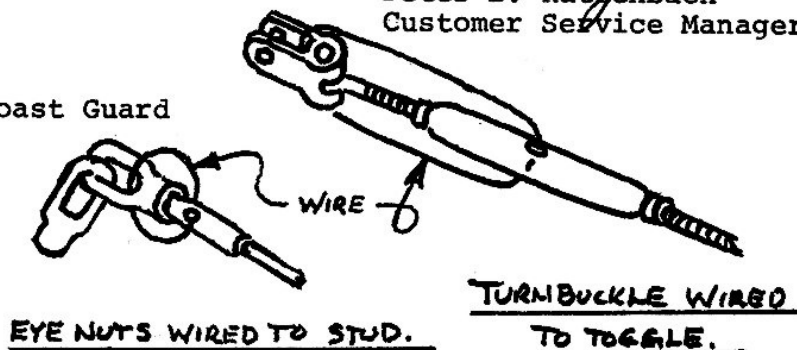
We've noticed that in some instances, it may be difficult to keep the locknuts tight enough on the lifeline turnbuckles to prevent the lifeline from becoming unthreaded. After studying the situation, it has been determined that if the turnbuckle barrels are wired to the adjacent toggles, and the eye nuts are wired to the hole in the threaded stud, the probability of the lifeline becoming unthreaded is virtually eliminated.

The following sketches will help you to understand the recommended steps. Enclosed herewith is four feet of 1 x 7 annealed stainless steel wire. It should be of sufficient quantity.
